Safe Coring and Drilling Areas Found Quickly, Efficiently

Accurate hand tool is easy to learn and use on reinforced concrete

BY LUKE M. SNELL AND YAGAANBUYANT DUINKHERJAV

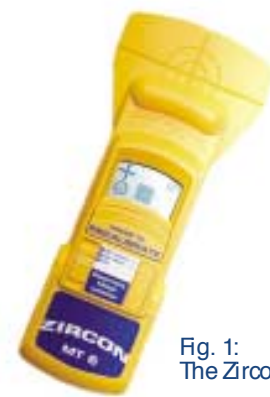
Fig. 1:
The Zircon MT6

to operate. Subsequent to this study, the company produced a new version costing less than \$200. In preliminary tests, the new locator, the Zircon MT6 (Fig. 1), performed even better than the 6.0 model.

The MT6 is relatively small at about 9 in. (230 mm) long, 3-3/4 in. (100 mm) wide, and 2-1/4 in. (60 mm) deep. The unit weighs about 10 oz. (290 g). It requires a 9-volt alkaline battery. The manufacturer's literature states that the unit's operative temperatures are 20 to 120 °F

(-7 to 49 °C) and that it can locate steel to an embedment of 6 in. (150 mm) within a ±1 in. (25 mm) accuracy.

Zircon Corp. posts on its website (www.zircon.com) step-by-step instructions for the use of the MT6. After turning the device on, a technician holds the instrument in an area of concrete that does not contain steel. After pushing its recalibration switch at this location, the technician then moves on to scan the concrete surface. It will give a beeping sound when it is directly over steel, and the depth of the steel is displayed on the built-in screen.

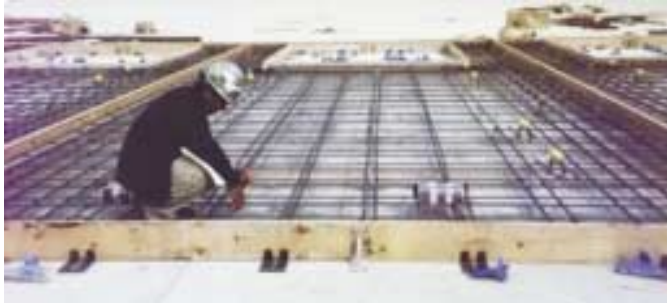
Fig. 2: Student in the U.S. prepares the as-built drawing

In setting up the field tests to ascertain if locations for safe coring could be identified, the construction site had been visited prior to concreting and an as-built sketch of the reinforcement positioning had been made. After the concrete was cast, a student with little experience in using the equipment sought to locate, with the metal locator, a safe area to core or drill.

When he found no steel present, the student marked the location to identify it as a safe area to core or drill. These locations were then compared to the as-built sketch, and were verified to be free of steel—thus being safe coring locations. The entire sequence is depicted in Fig. 2 to 4.

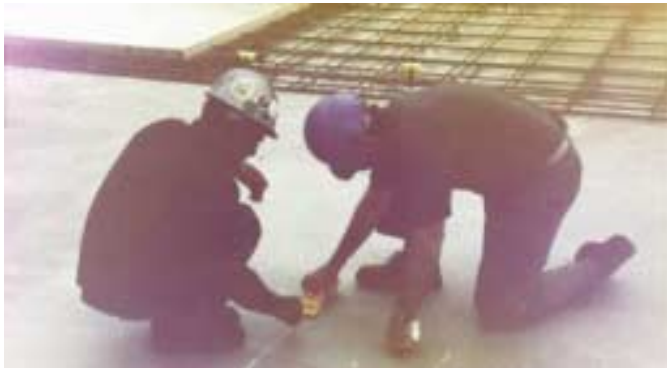
Fig. 3: Students scan and mark the concrete surface

He first determined the position of the steel by scanning along the surface of the concrete and putting chalk marks initially at the location of the embedded steel. Next, he moved approximately 3 ft (1 m) on each side of the marked location and scanned the surface again marking as necessary. The chalk notations were then connected. He repeated the entire procedure, with scanning as well at 90 degrees from the original locations observed. The resulting grid indicated the positioning of the reinforcement. The areas between the marks were in turn scanned to check for freedom from steel.

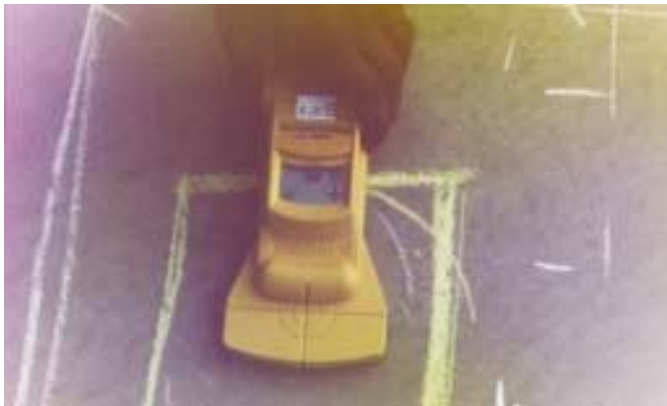
Fig. 4: A "safe" location is found and marked

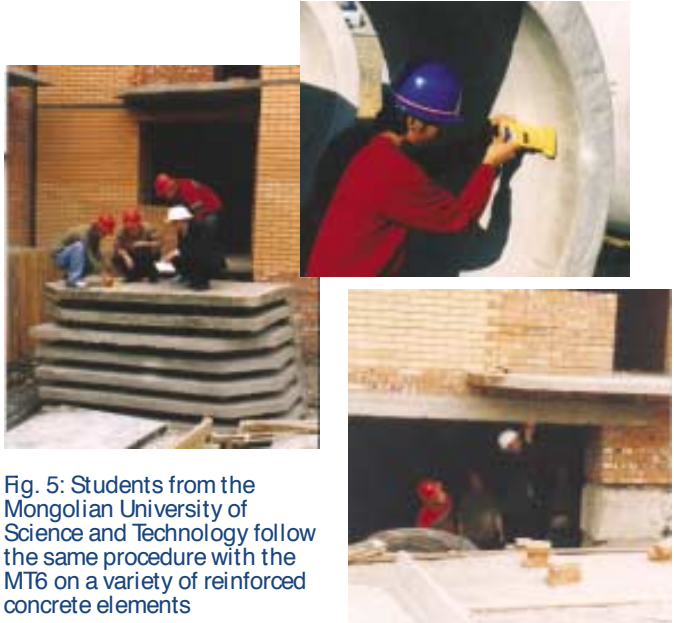
Fig. 5: Students from the Mongolian University of Science and Technology follow the same procedure with the MT6 on a variety of reinforced concrete elements

Mongolian students followed the same procedures. They, too, were able to locate steel reinforcement in precast concrete pipe and slabs and on a construction project as shown in Fig. 5.
